CJ Ord River Sugar Report on Hydrosmart Operation 2003

Author: Mick Conroy – Production Manager – CJ Ord River Sugar

Background & History

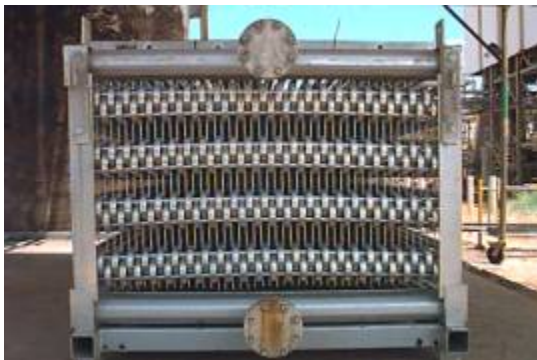
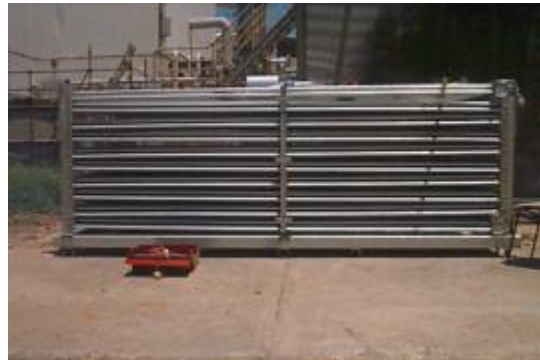
The cooling tower unit when initially installed was complemented with a chemical dosing program to control deposits in the system and to condition the water supply. After the 2002 crush season inspection of the outside of the cooling coils revealed large deposits of scale on the surface of the units. These 2 cooling coil units had to be sent away to be cleaned and regalvanised which cost approximately \$20,000. Please see following photos of the cooling elements after repair

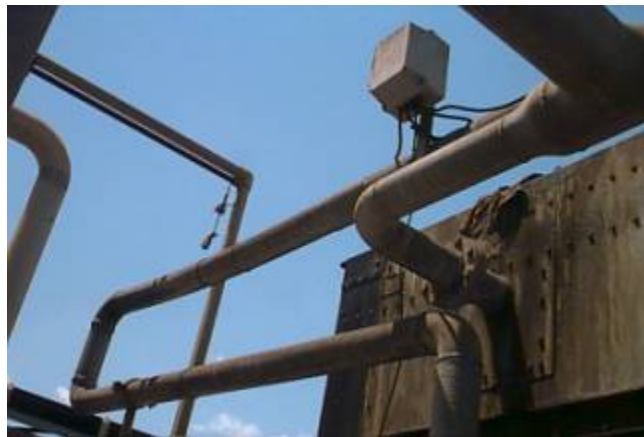
Fig 1

The unit was installed approximately 2 metres from any electromagnetic force (achieved by modifying PVC pipe work). See figure 1. – Hydrosmart Installation on cooling tower outer water circuit.

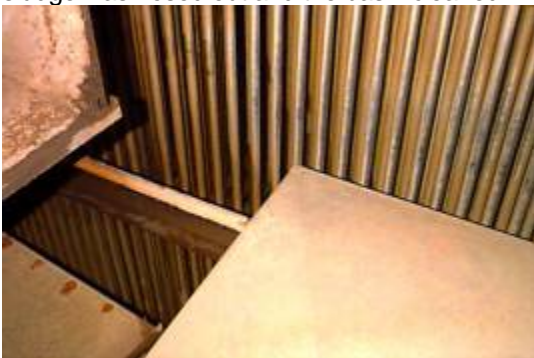
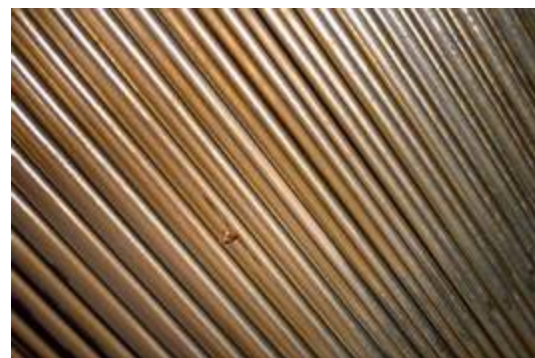
Water from the outer water circuit was collected every day during the trial period to analyse it for Phosphate and pH. The data in the log sheet (next page) represents tests carried out on the water supply from the 26/5/03 to the 08/7/03. The conductivity of the external water circuit steadily rose as expected to a point where we made a conscious decision to bleed the solids suspended in the water out of the circuit and make up with clean water. After the first week of the crushing all chemical dosing was stopped except for chlorine addition on a weekly basis to help combat bacterial growth in the tower. A full internal inspection of the tubes was performed 13 weeks after bringing the system online. The tubes were still in a shiny state and the basin of the tower was covered in a sludge 10cm deep, this sludge was hosed out and the basin cleaned.
