California Winery Cleans Up Heat Exchanger

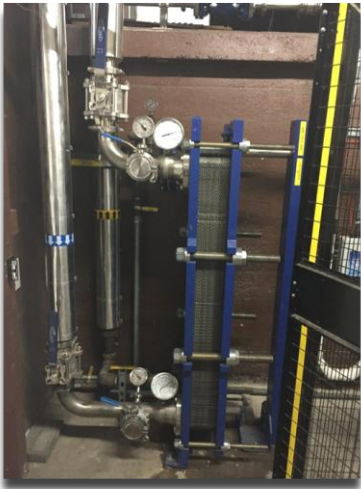
Photo on left above shows the heat exchanger, second shows the installed Hydrosmart and Doug Ryerson, of Hydrosmart's Western USA agency is shown in the right hand photo above holding a bag with just some of the scale that was removed after several weeks of Hydrosmart treating the heat exchanger feedwater.

A two-inch Hydrosmart system was installed on a heat exchanger that carries hot water of 82 degrees Celsius (180 degrees F) and 80 PSI, to heat cold water. The Hydrosmart operates within these conditions to remove and prevent scale build-up on the heat-exchanger's plates.

The existing scale was causing a problem and reduced efficiencies and downtime and electronic water conditioning was identified as the appropriate solution. After a few weeks of operation of the Hydrosmart, bags of scale were being harvested, and after a couple of months, the multiple plates were clear of hard scale. Function and efficiency of the heat exchanger improved. In fact, something the operators had never seen before has enabled more efficiency and lower energy costs!
